Potential Environmental Impacts of Quarrying Stone in Karst— A Literature Review

U.S. Geological Survey
Open-File Report OF-01-0484

By William H. Langer

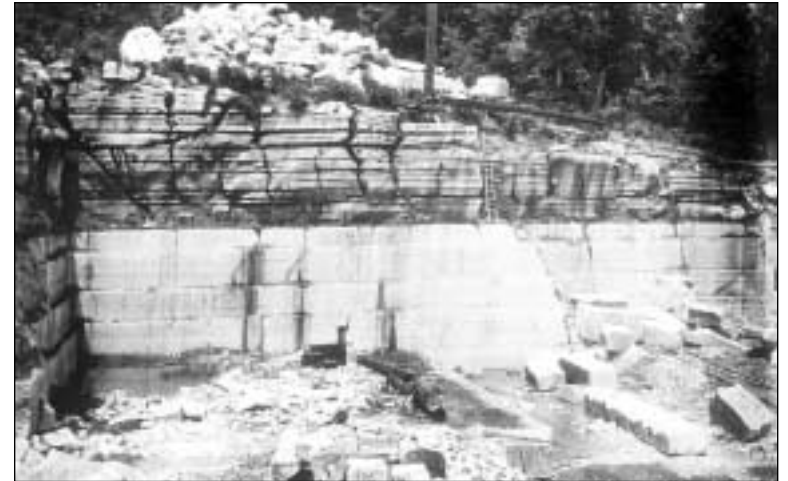
Figure 4. Dimension stone quarry showing weathered outcrop (top) and smooth working face of quarry. Vertical solution channels following fractures and joints in the weathered outcrop extend down into the smooth working face. Horizontal solution features occur between beds of the rock. Notice ladder for scale. (USGS photographic library - Loughlin 154.)

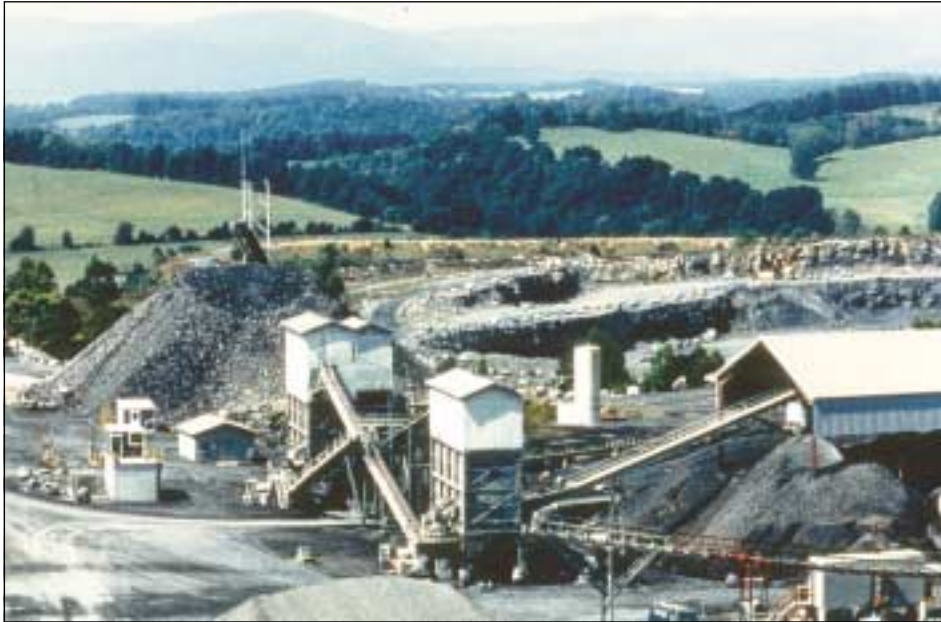
Figure 10. Engineering techniques, such as enclosing equipment and removing dust using vacuums, can mitigate impacts of noise and dust. (Photograph courtesy of Luck Stone.)

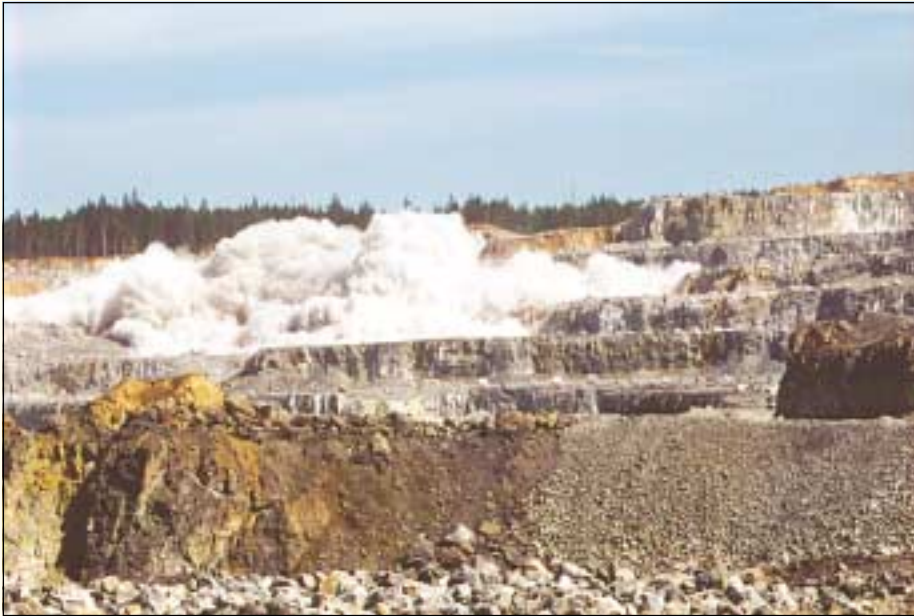
Figure 12. Rock is drilled and blasted for use as crushed stone. In some isolated areas where people are not located nearby, larger amounts of explosives may be used.

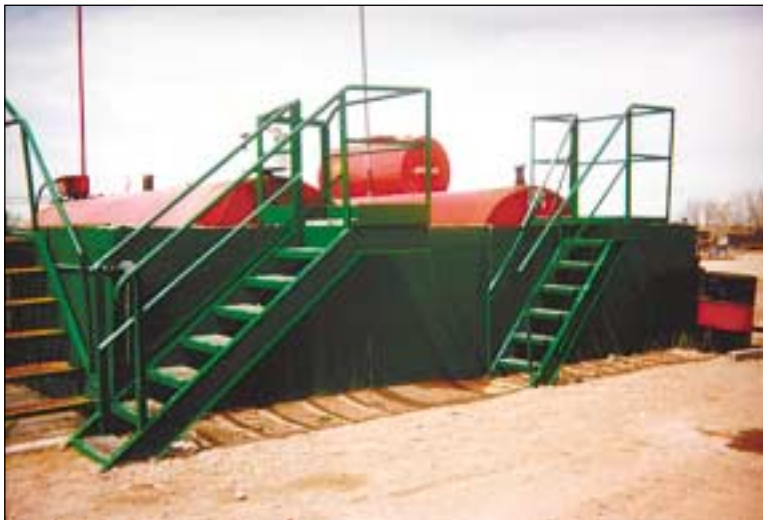
Figure 17b. Properly constructed containment facilities can protect the aquifer from potential fuel spills. (Photograph courtesy Lafarge.)

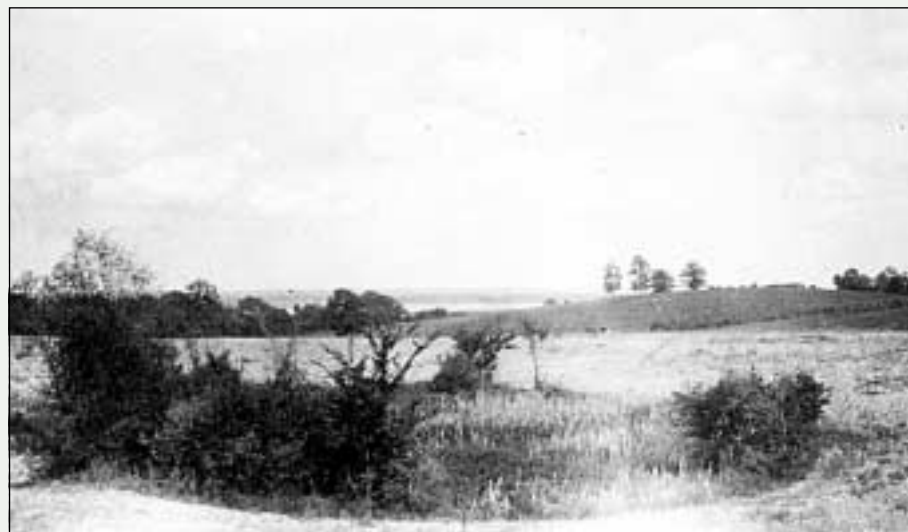
Figure 18. Natural sinkhole near Ste. Genevieve, Missouri (*USGS photographic library-Shaw #891*).

Natural sinkholes (fig. 18) can form through the dissolution of rock (solution sinkhole) or through the failure of a bed-rock roof overlying a cavern (collapse sinkhole). The formation of both of these types of sinkholes occur over periods of geologic time, not within a human lifetime. The solution of rock has little to do with the final cause of sinkhole collapse, however, it can set the stage for some human-induced event in the future (Thorpe and Brook, 1984; White and White, 1995). Of an estimated 4,000 sinkholes formed in Alabama between 1900 and 1976, only 50 were natural collapses (Newton, 1976).

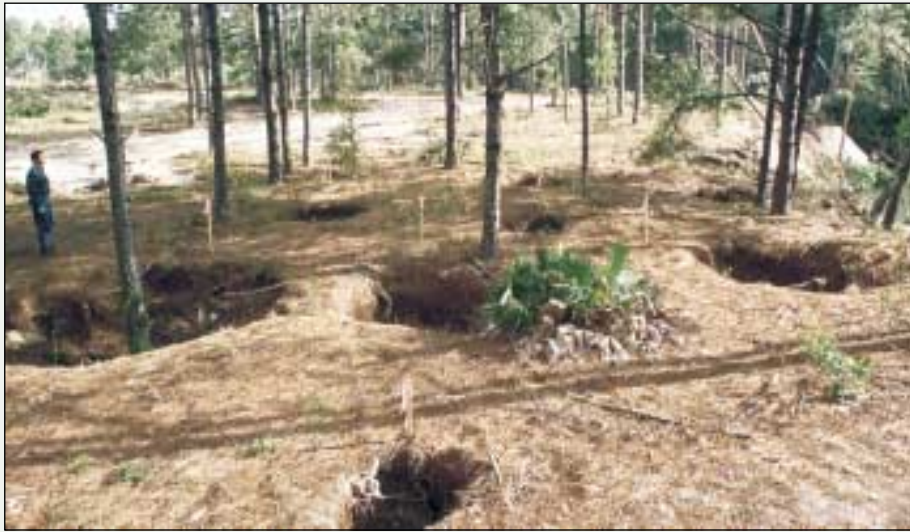
Figure 19. Human-induced sinkholes formed during the development of an irrigation well affected a 20-acre area and ranged in size from less than 1 foot to more than 150 feet in diameter. (Photograph courtesy Ann Tihansky, USGS.)

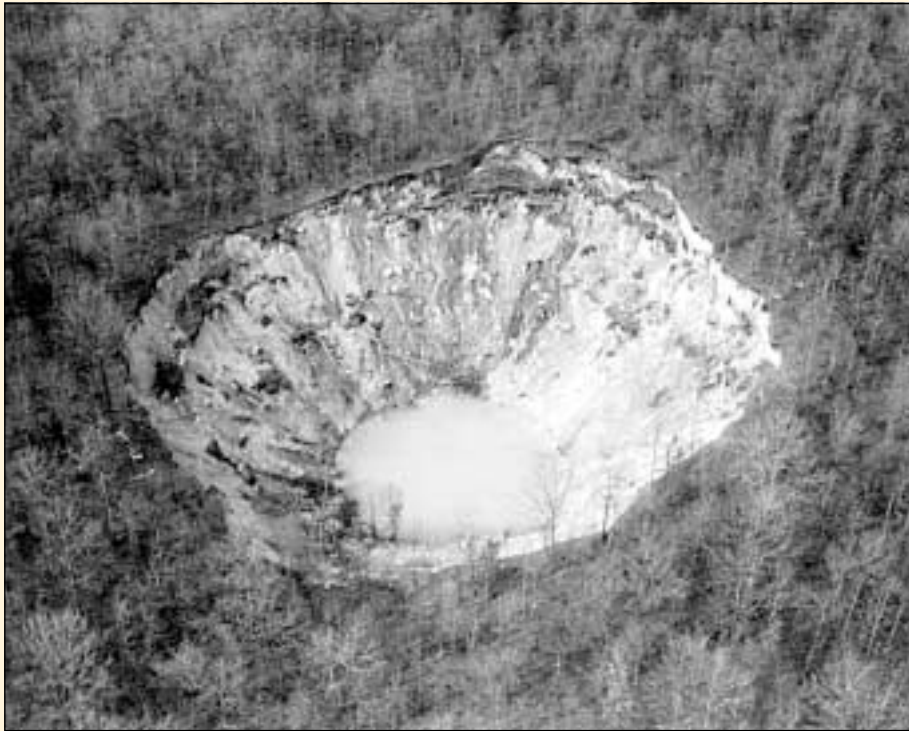
Figure 23. The “December giant,” a large sinkhole, developed rapidly in Shelby County, Alabama, in December 1972. The sinkhole measures 145 m long, 115 m wide, and 50 m deep. (USGS Photographic Library-USGS #140.)

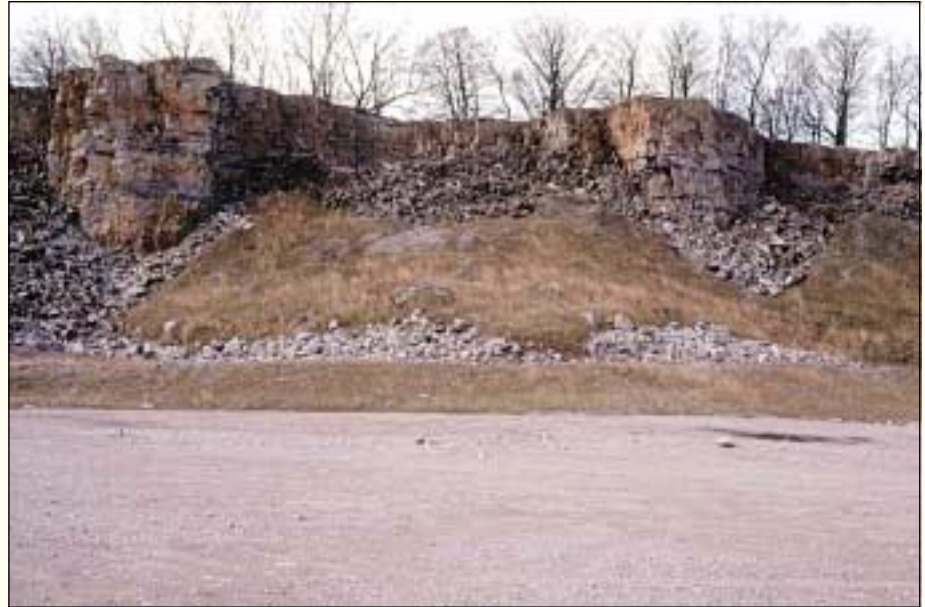
Figure 24. Face of limestone quarry after restoration blasting and habitat reclamation. (Photograph courtesy John Gunn.)
